CASE HISTORY – REFINERY DECONTAMINATION WITH PARATENE® D740/D742

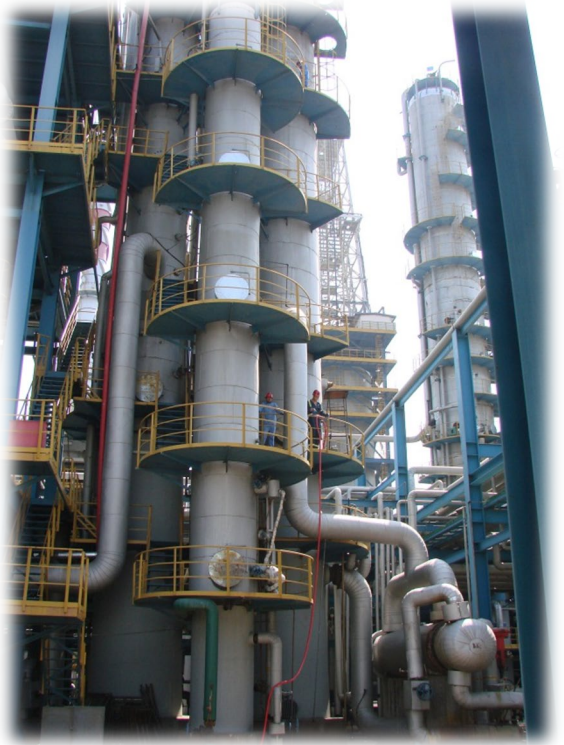
Cleaning a
distillation tower.

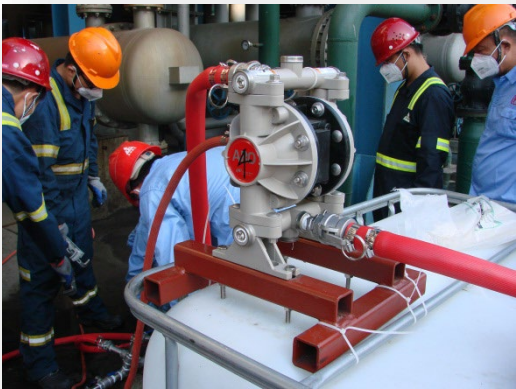
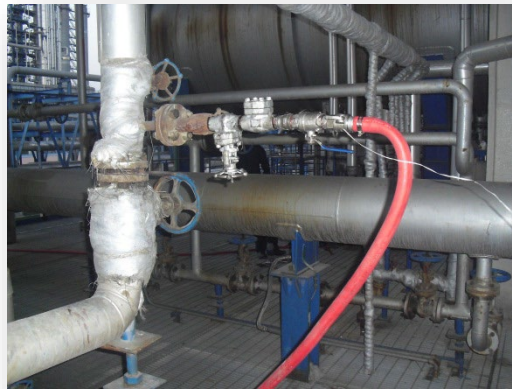
Chemical Injection

In each system Paratene® D740 was added to the steam followed by D742.

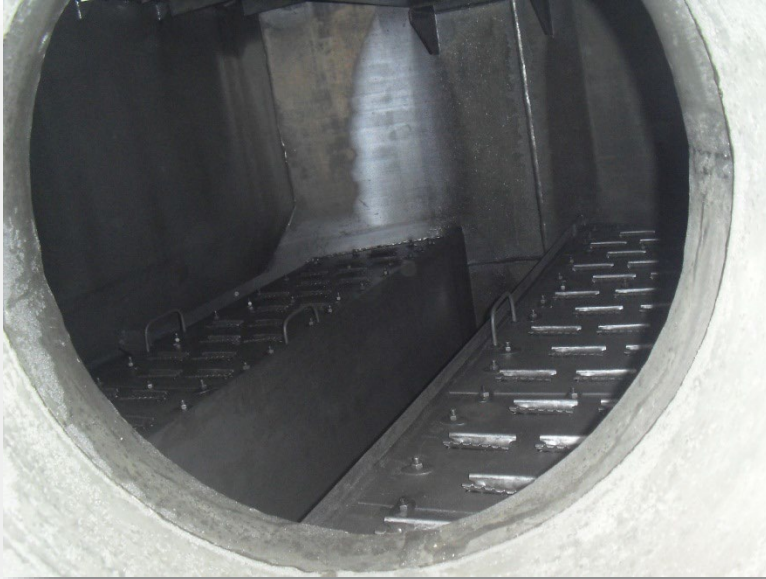
Interior view
after cleaning

No Hydrocarbon
vapour could be
detected from
the tower after
cleaning.

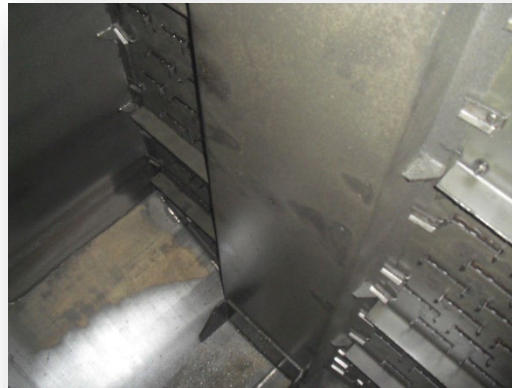
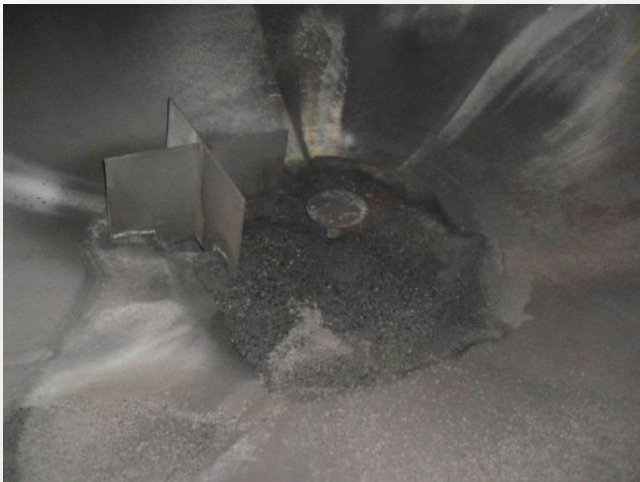
Previous cleaning
had severe
problems with
pyrophoric iron
sulfides.
